## **Development of high- performance Nano-alu material**

Development of high performance light weight structural  
materials by synthesizing ceramic nano-particles with  
Aluminum alloys matrices

Examination of specimens that were produced by ECENARRO and by  
EDERTEK

July, 2012

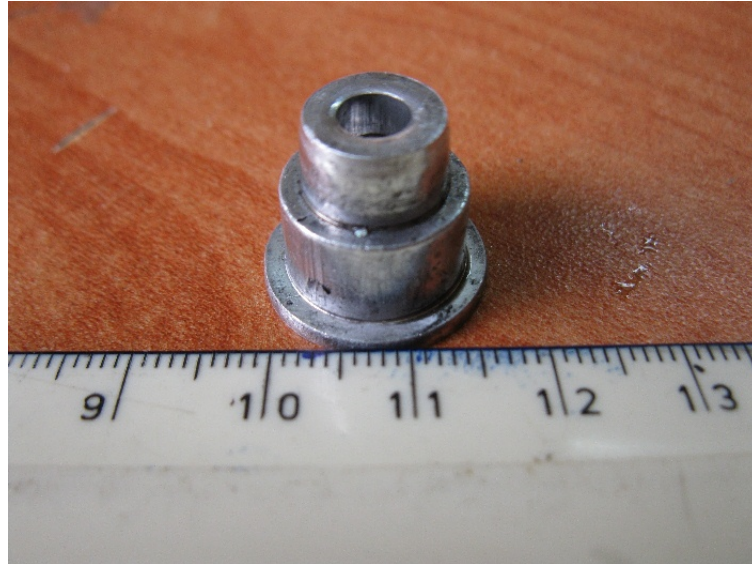
A picture of a typical specimen that was tested:

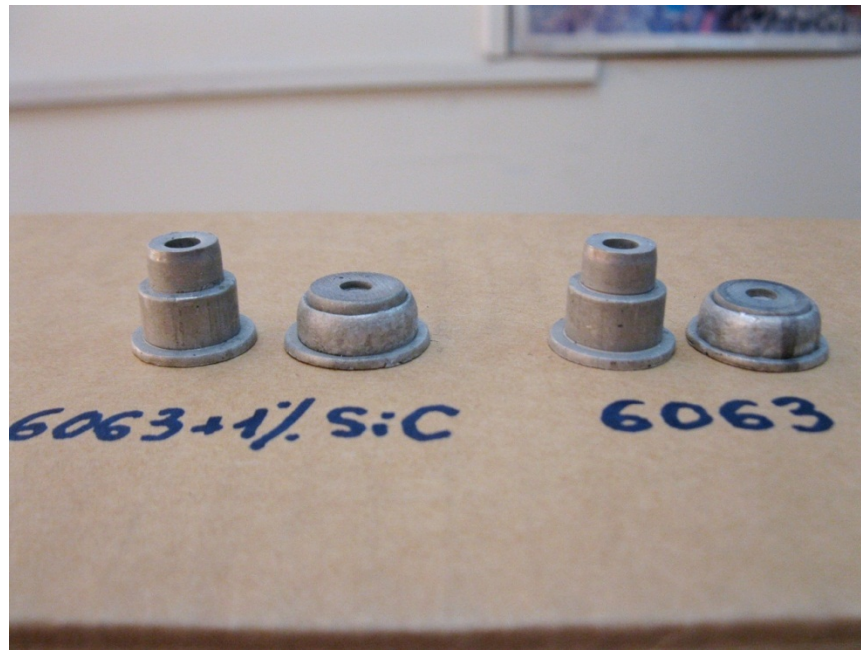
Specimens before and after compression tests are shown in Fig.1

Fig.1- Specimens before and after compression tests.

Comparative compression tests were carried out for comparison between two groups of specimens: 1. 6063 alloy and 2. 6063 alloy reinforced with 1%SiC nano-particles. 4 types of specimens from each group were tested: F (as fabricated), T4, T5 and T6 heat treated.

6 specimens of each group were tested. The specimens were tested on "INSTRON 3369" mechanical testing machine.

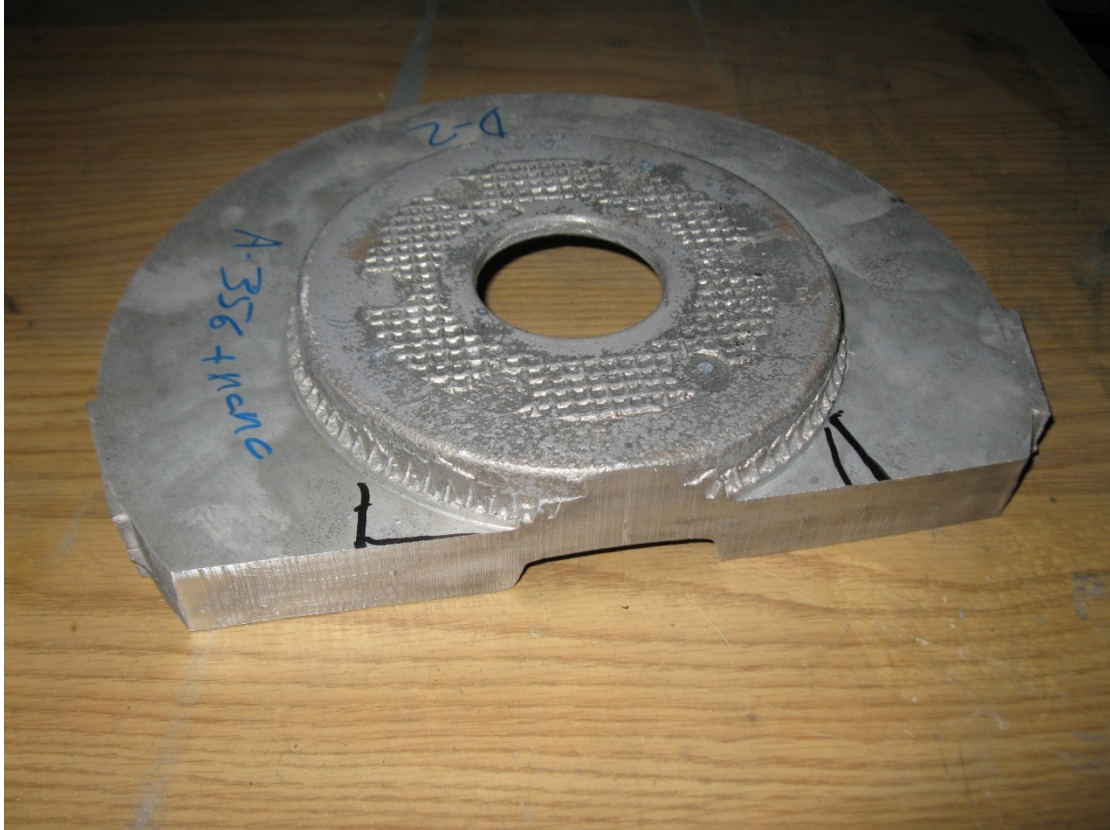
From each disk, 2 specimens for tensile tests were prepared. The tension spencimens were cut out of the disks (fig 1).

Fig.1 . The disk after cutting out tensile specimens.

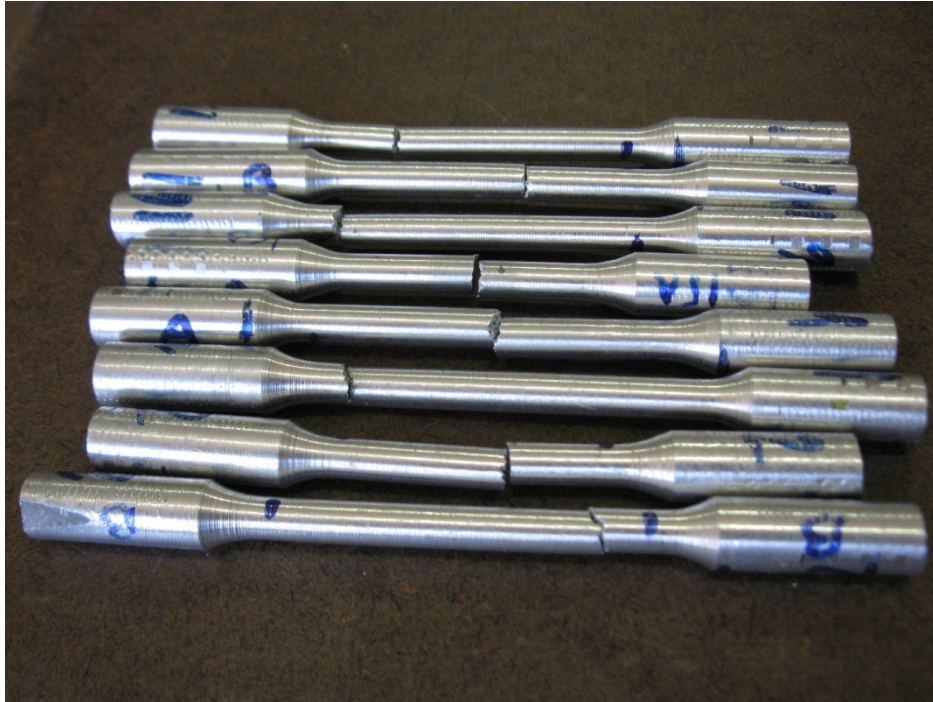
Specimens with a diameter of 6.0mm and a length of 120mm were prepared from disks, for tensile tests.

Fig. 2- the specimens after the tension tests
